Advanced Duct Sealant Testing

CONSULTANT REPORT

SEPTEMBER 2003

500-03-079

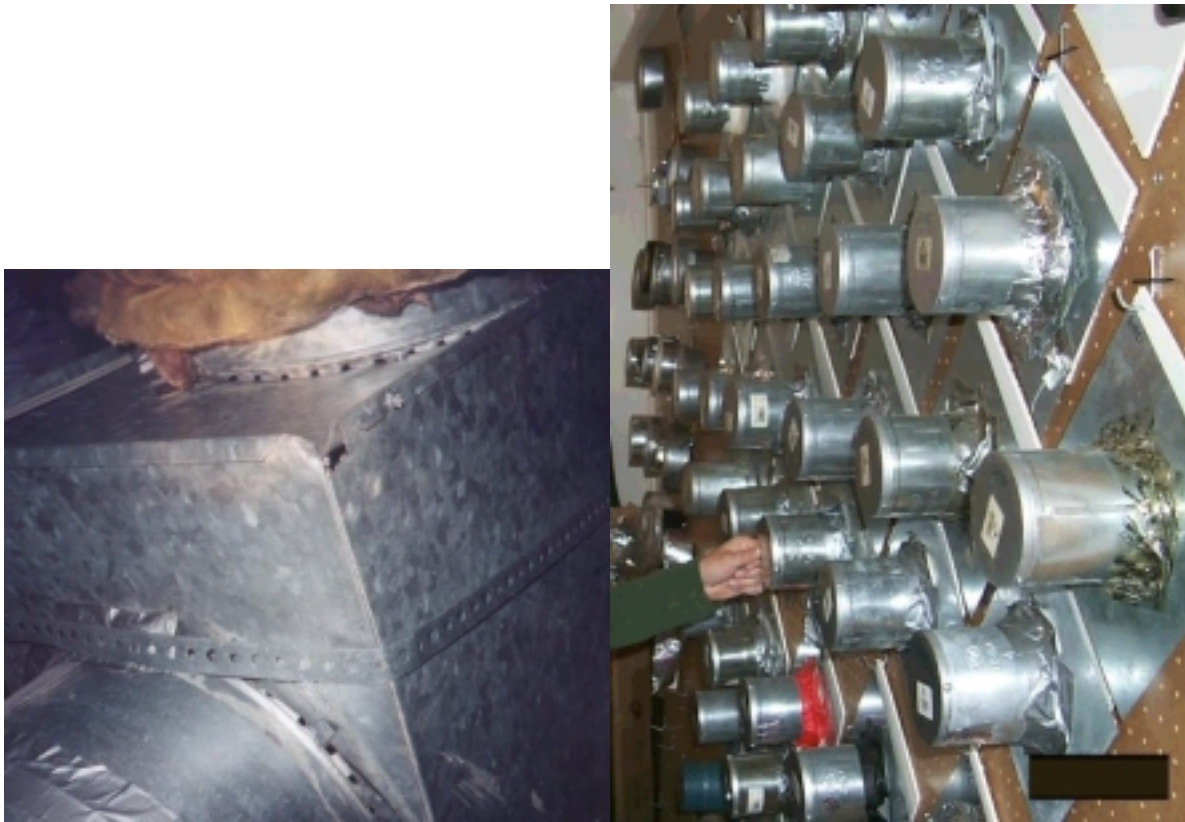
Figure 2. Example of collar-to-plenum connections on a system where the tape sealant has fallen off, and a collection of collar-to-plenum test samples from LBNL.

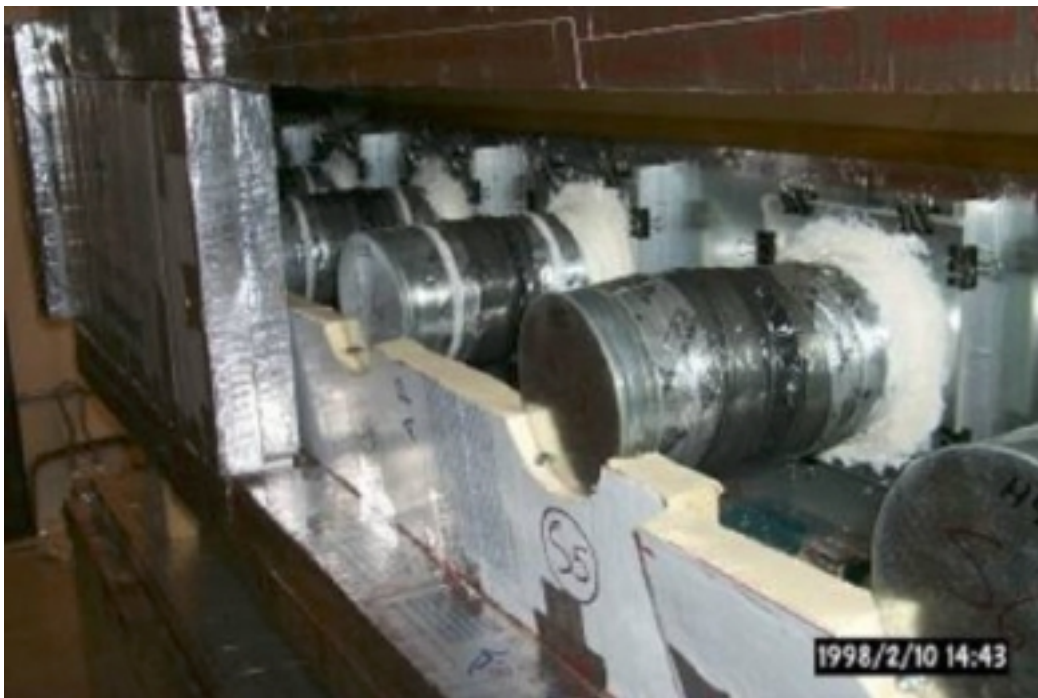
Figure 3 shows samples mounted on the aging test apparatus. Heated air is continuously circulated through the test apparatus to both heat and pressurize the leakage sites. The apparatus is divided into an upper and lower chamber that each contains nine samples. The inside of the test samples are exposed to high pressure heated air and the outside (shown in Figure 3) is in an insulated chamber that also becomes heated during the experiments by conduction through the test samples. This means that there is little temperature gradient across the samples. The hot air temperature is controlled using electric resistance heaters mounted directly in the air stream. The surface temperatures of each sample, the air temperature and the pressure across the leaks are continuously monitored using a computer based data acquisition system. The actual leakage measurements are conducted periodically (typically on a monthly or weekly basis) by removing the samples from the test machine. They are then allowed to cool to room temperature before being placed in a separate testing device that pressurizes the samples to 0.1 in. water (25 Pa) and measures the air flow rate required to maintain this 0.1 in. water (25 Pa) pressure difference (Figure 4). Small deviations leakage flow due to the actual pressure obtained during the test not being exactly 0.1 in. water (25 Pa) are corrected to the 0.1 in. water (25 Pa) reference. This 0.1 in. water (25 Pa) air flow is the leakage of the sample that is then recorded and compared to initial 0.1 in. water (25 Pa) air flow measurements of the connections before and after initial sealing.

Figure 3. One Chamber of the High Temperature Aging Apparatus

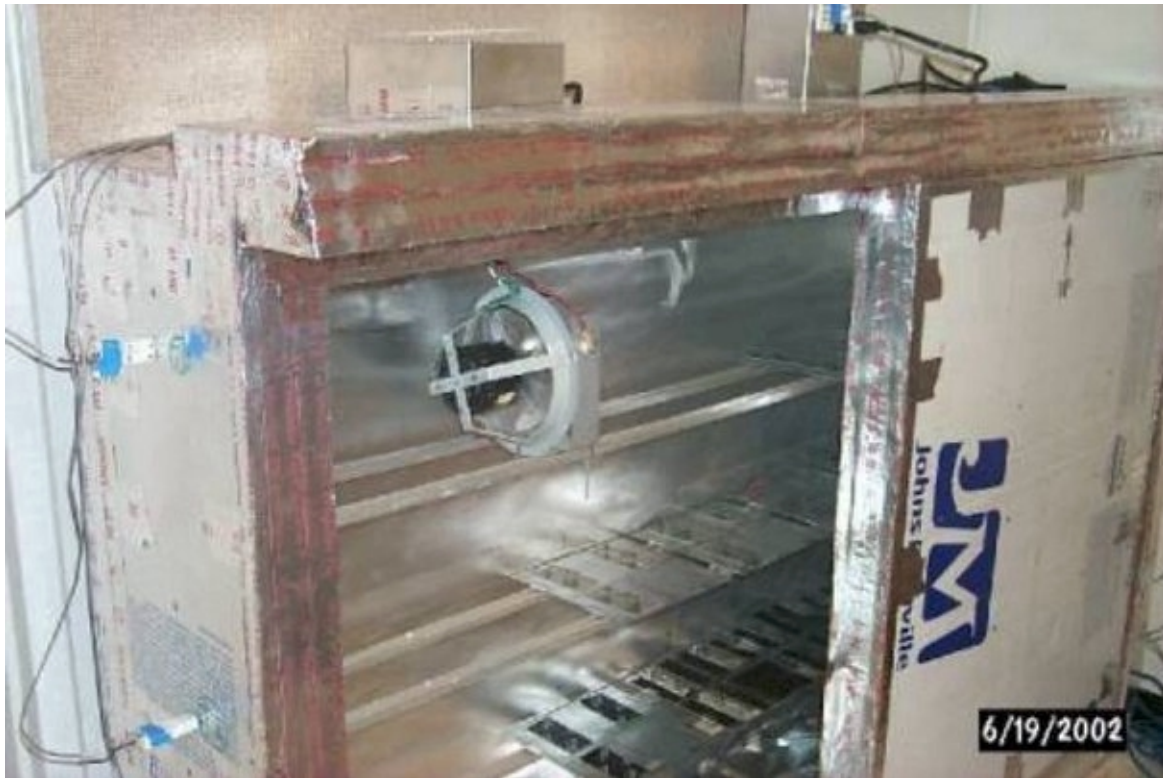
Figure 6 shows the baking test oven that provides constant circulating air temperature of 212°F (100°C) for the baking specimens following the UL 181B-FX “temperature test” protocol. All walls of the oven are made with 4” (100 mm) thick foil-faced foam sheathing. The bottom of the oven, sitting on the floor, is made thicker (6” (150 mm)) for added insulation. The oven is 44” (112 cm) high, 72” (183 cm) wide, and 10” (25 cm) deep. It contains four racks made of two strips of aluminum that hold the testing specimens. Six temperature sensors equidistantly placed on both sides of the oven provide readings of the temperature profile inside the oven. Measured results show that the temperatures do not vary by more than 5°F (2.5°C) from the average temperature of 212°F (100°C). The oven has an electric heating unit controlled by a relay box to turn off at 214°F (101°C) and on at 210°F (99°C), and also protected by a safety snap thermostat rated at 250°F (121°C). The temperature values are recorded at a one-minute interval.

Figure 6. The High Temperature Baking Apparatus

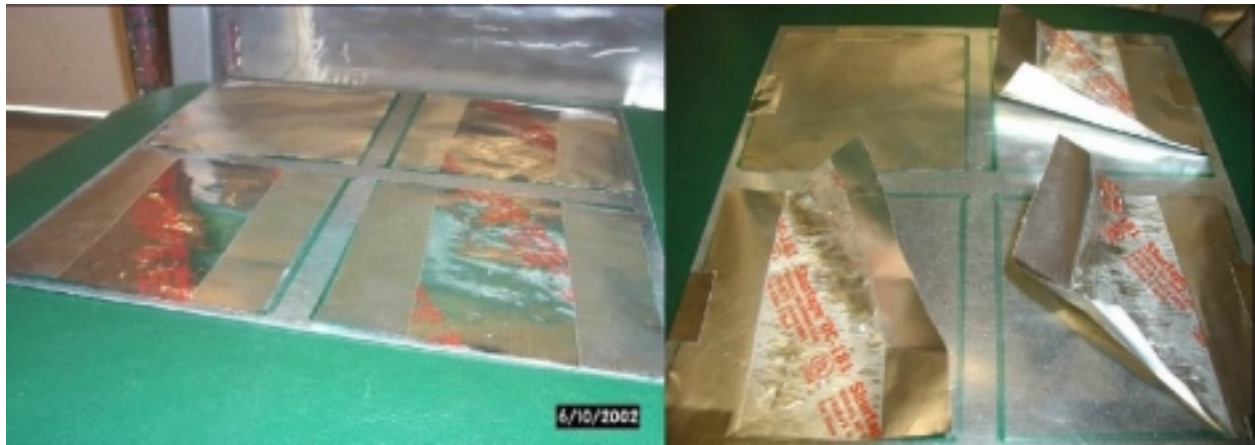
sample, all carried by a sheet metal tray in the oven (Figure 9). Since the substrates used in this test are very thin and light weight, they are attached from two sides to the sheet metal tray so that the fan can not blow them away from their locations.

Figure 9. A baking specimen following the UL 181B temperature test protocol consisting of three samples of tape (Tape 3) and one control sample of the substrate (Aluminum Foil) before testing (left) and after four weeks of testing (right)

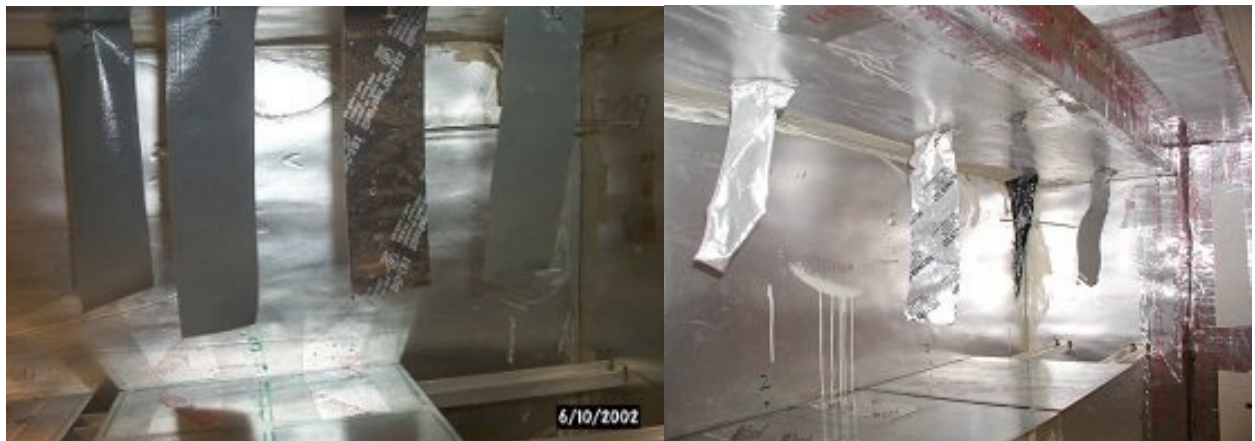
In addition to the specimens following the UL 181B temperature test protocol, we included “hanging specimens” (Figure 10) of all four tapes in the oven to examine their deterioration in isolation from the substrate they are applied to.

Figure 10. . Hanging specimens of Tapes 1 to 4 in the high temperature baking apparatus before testing (left) and after three weeks of testing (right).

tape tested which were hung in the oven without being applied to any substrate showed considerable deterioration after only two weeks of baking.

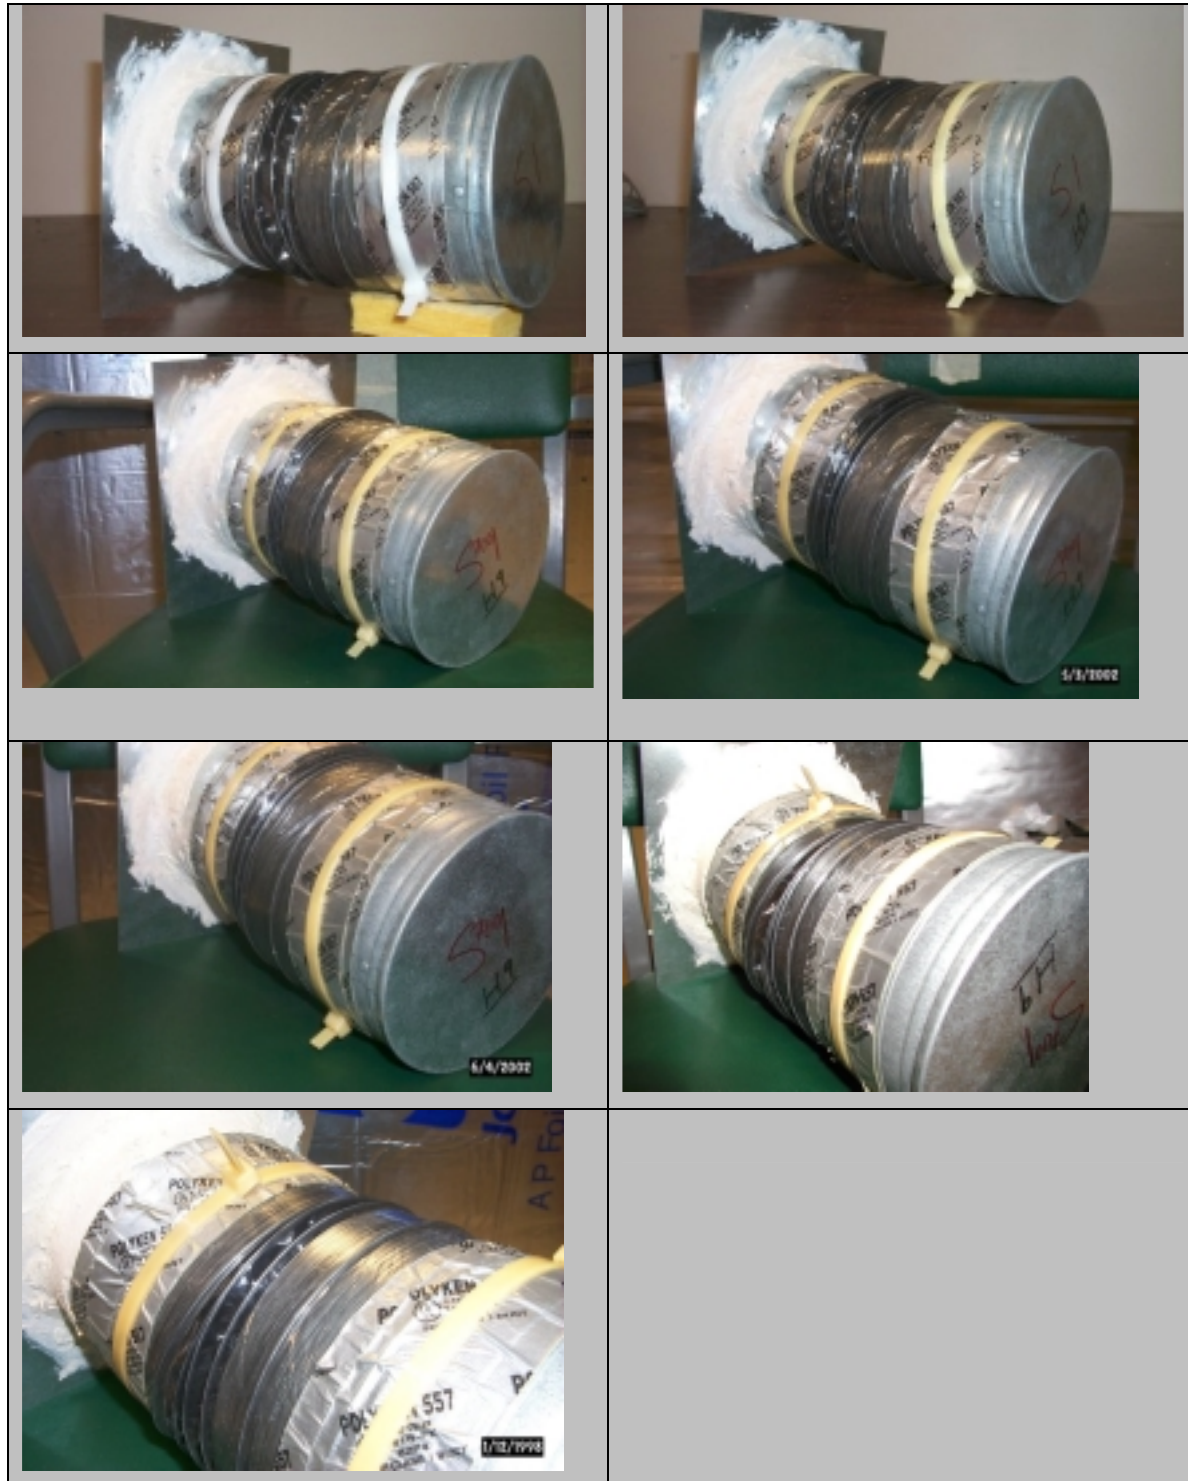
In order to systematically record the visual deterioration of the samples, monthly pictures of all 18 specimens were taken. Typical minor deteriorations were observed as discoloration, wrinkling, and oozing, and major deteriorations were shrinking, peeling, delamination, and cracking. Figure 11 shows the deterioration of one of the specimens with clamping, and 2 continuous wraps of duct tape.

Figure 11. Deterioration of flexible duct core-to-sheet metal collar joint during the six months of the aging test.

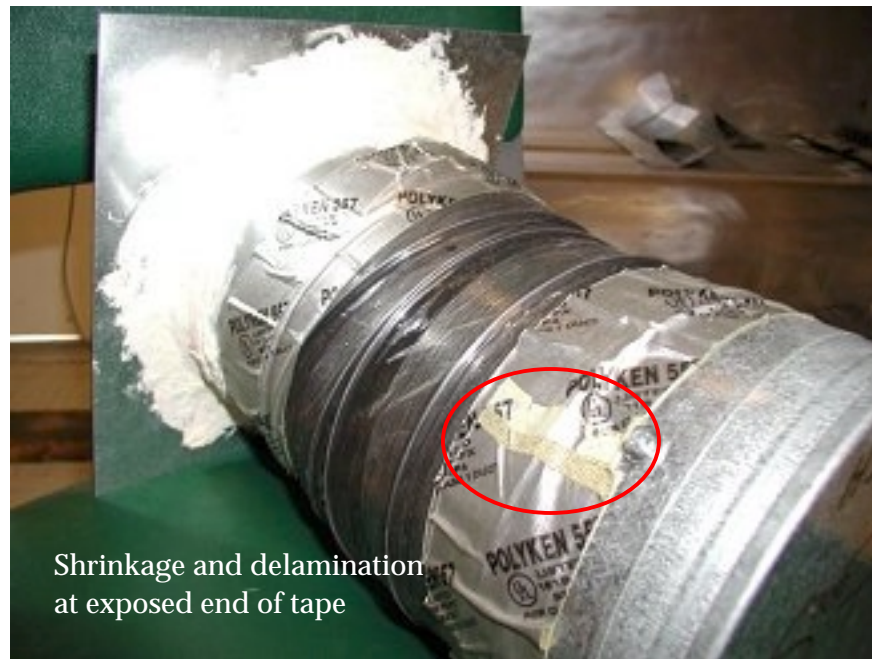
- shrinkage and delamination among the unclamped specimens (Figure 12)
- oozing of the adhesive layer in the foil-butyl tape (Tape 4) specimens (Figure 13)
- little shrinkage and delamination in the strapped specimens
- discoloration of the plastic strapping in the clamped specimens

Figure 12. Shrinkage And Delamination Among The Unclamped Specimens (After 5 Months Of Aging)

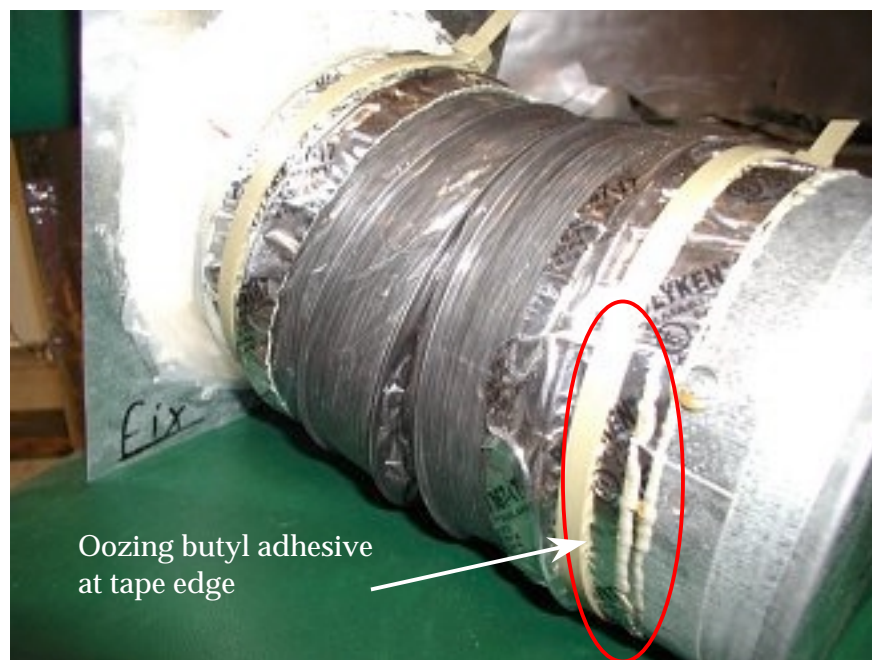
Figure 13. Oozing Of The Adhesive Layer In The Foil-Butyl Tape (Tape 4) Specimens (Showing Result Of 5 Months Of Aging).

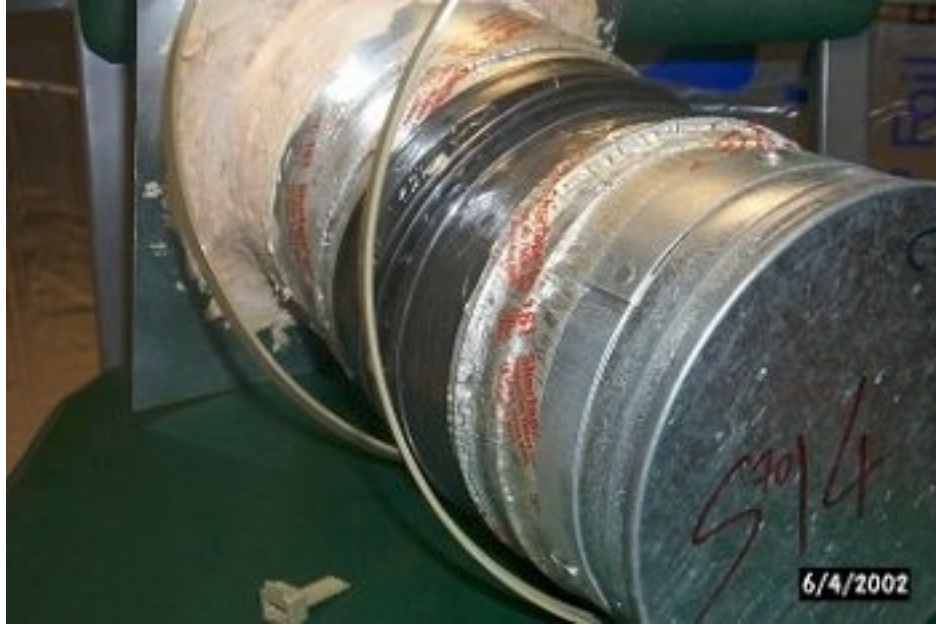
The discoloration of the plastic strapping was an indication of its deterioration which basically lead to a total failure afterward in one case (specimen S7014) after four months of aging. The plastic clamp cracked open due to the increased brittleness of the plastic (Figure 14).

Figure 14. The Failed Plastic Strapping On One Of The Flexible Core To Sheet Metal Collar Specimens After Four Months Of Aging.

A surprising result was that almost all the clamps used in our testing failed during the 500 days of testing. They all failed in the same way – becoming discolored and brittle and finally falling off the samples. For this reason we recommend either requiring metal clamps or we need to test a wider range of clamps to determine if some materials perform better than others. Given that clamps are required as part of a UL181B-FX sealing system, this failure of clamps is a very important issue. It should be noted that the UL181B-FX system requires the use of clamps but does not test them or have any other performance requirements for the clamps. This significantly reduces the utility of specifying a UL 181B-FX listing in a building code as a method of ensuring acceptable performance.

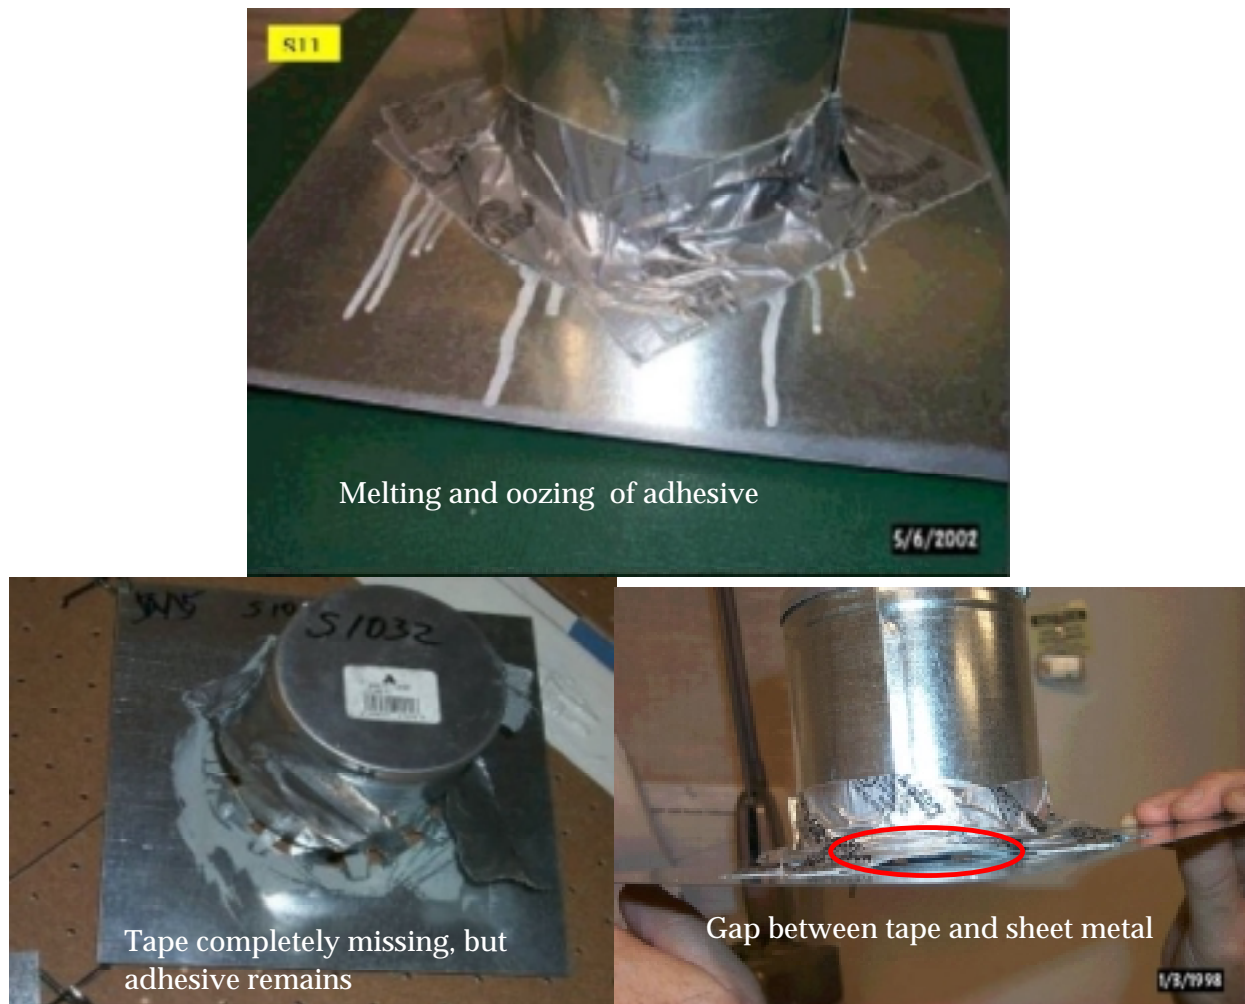
Figure 21 shows the failure of the joint as the duct tape tends to pull away from the sheet metal, thus uncovering the series of overlapping fin-joints.

Figure 21. Example Failures Of The Collar-To-Plenum Join

The two tapes (including a new tape developed specifically for this application) tested on the “collar-to-plenum” connection failed over a range of a few days to about four months. This is similar performance to previous testing by LBNL. The only cloth tape using butyl rubber we tested performed substantially better than other cloth tapes, but not as well as all other tapes or mastic.
